Modular Gabion Systems

Process

Anegada Reef Hotel, Anegada, BVI

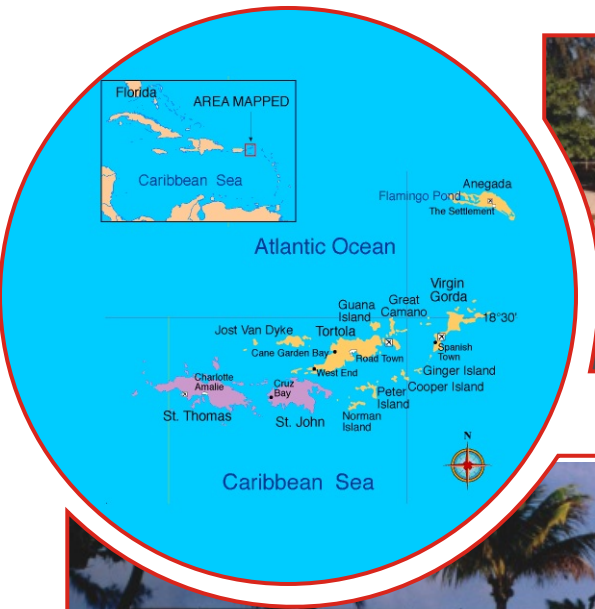
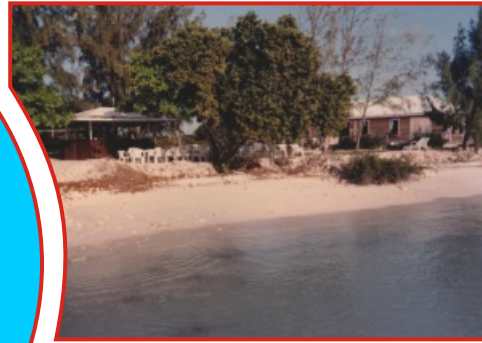
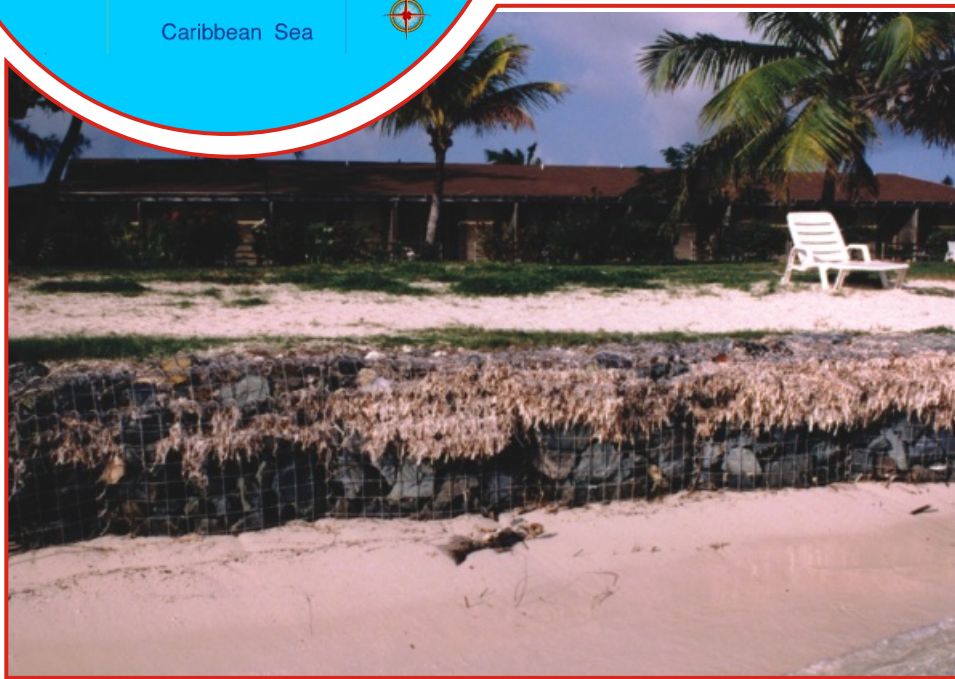
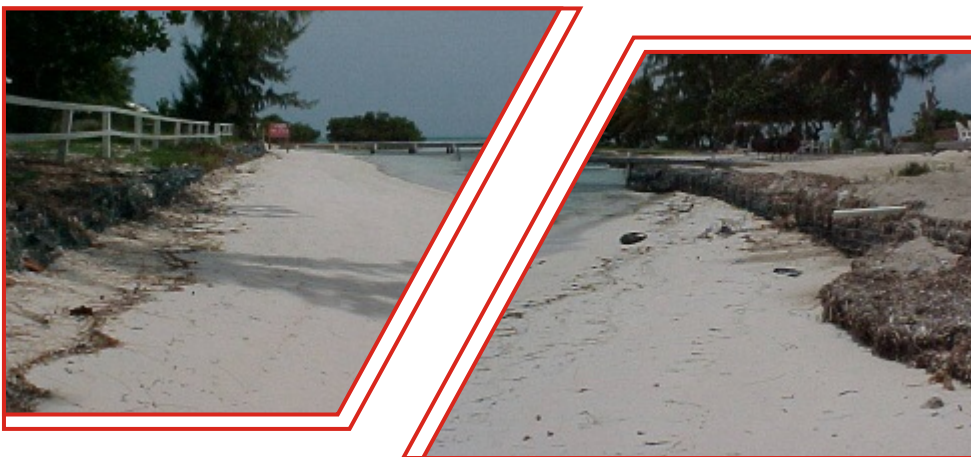
In 1995, the island of Anegada was savaged by two major hurricanes, Luis and Marilyn. When the storms had passed, little was left of the beachfront at the Anegada Reef Hotel; storm surge had washed away nearly 60 feet of beach. (Note the proximity of the shoreline to the trees in the early photos.)

After weighing various options for shoreline protection and restoration, the property owners elected to build a porous and flexible Modular Gabion Systems breakwater at the approximate location of the pre-erosion shoreline. The decision to use gabions reflects the owners' need for proven erosion control, respect for the natural environment and cost effectiveness.

In the years since construction, the entire area between the eroded shore and the breakwater has returned to beach. The breakwater deflects wave energy causing entrained sand to drop from suspension and collect behind the structure. The gabions, now barely visible, continue to protect the island.
